# Whiskers on Monitor PCBs

September 5, 2008

Two (2) failed monitors were physically examined to assess potential failures. Long metal whiskers ( $> 900$  microns) were observed on USB housings. Failure of monitors not directly linked to tin whiskers.

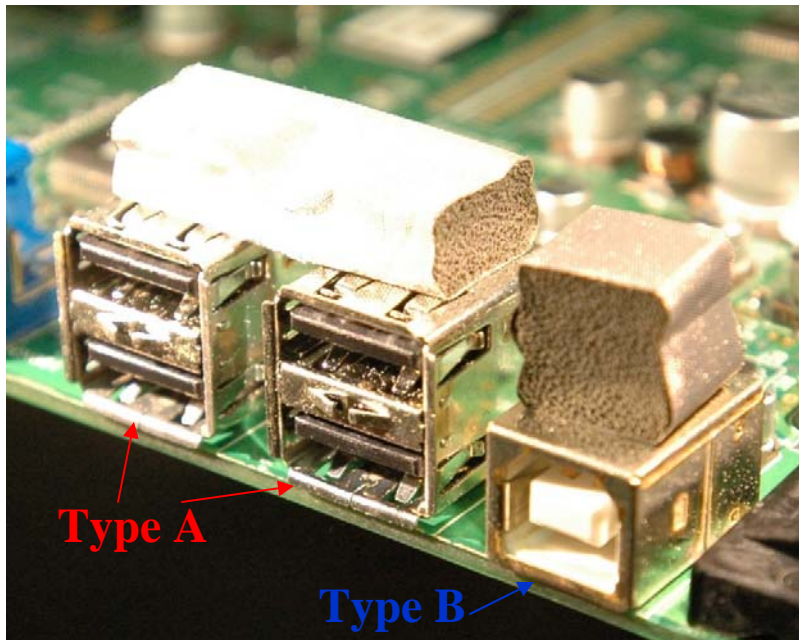
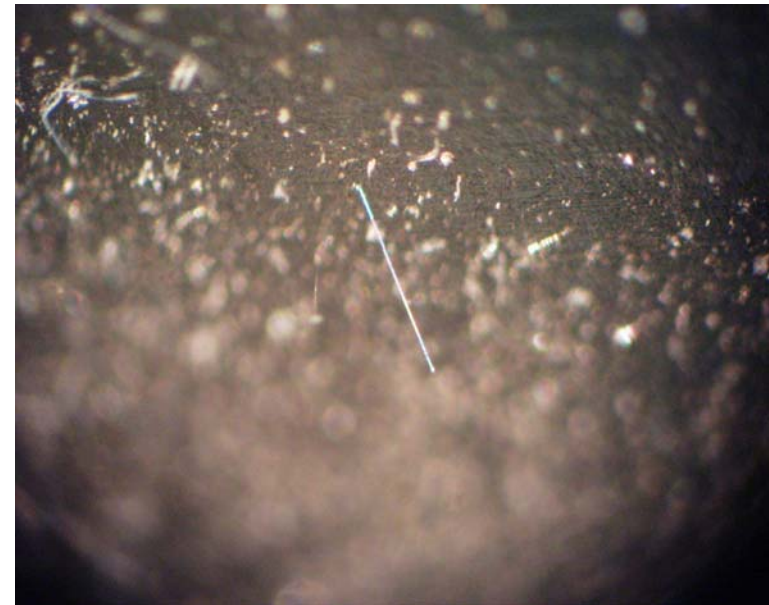
- Five USB ports: four of type “A” and one of type “B” – all unmarked
  - Whiskers found on the metal housings of the ports

**Example of a whisker on board 0335  
(USB A) under optical microscope**

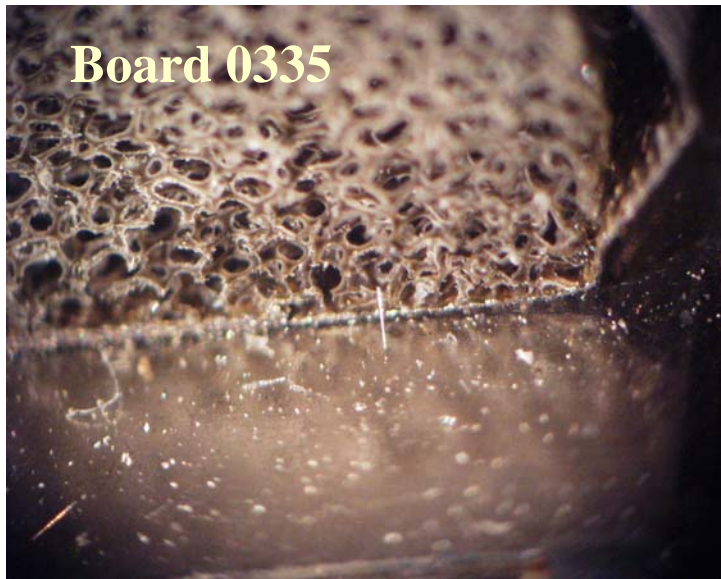
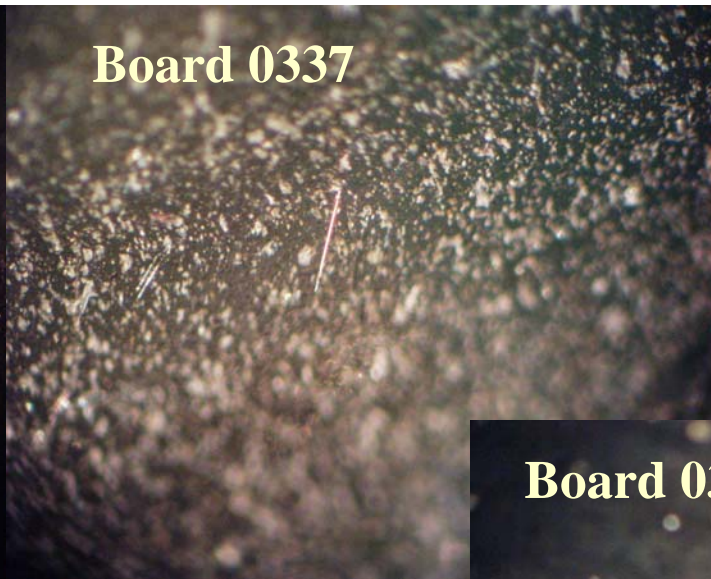
**Long Filament-type whiskers**

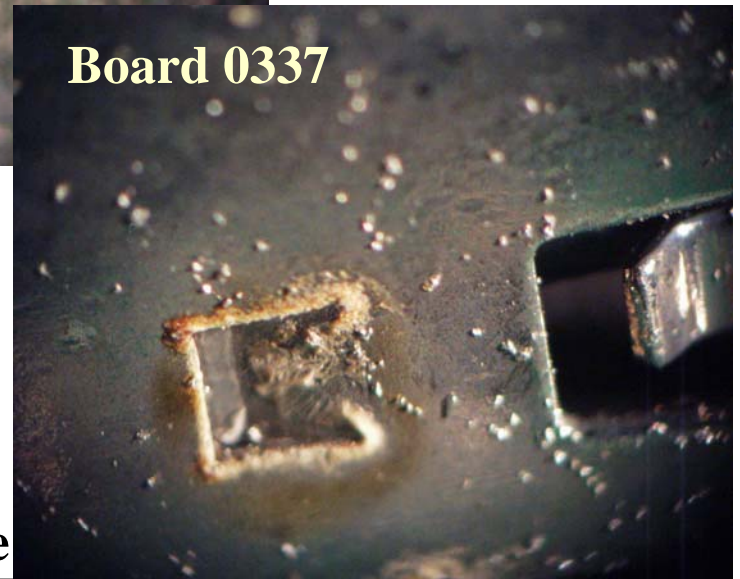
**Nodules on the surface**

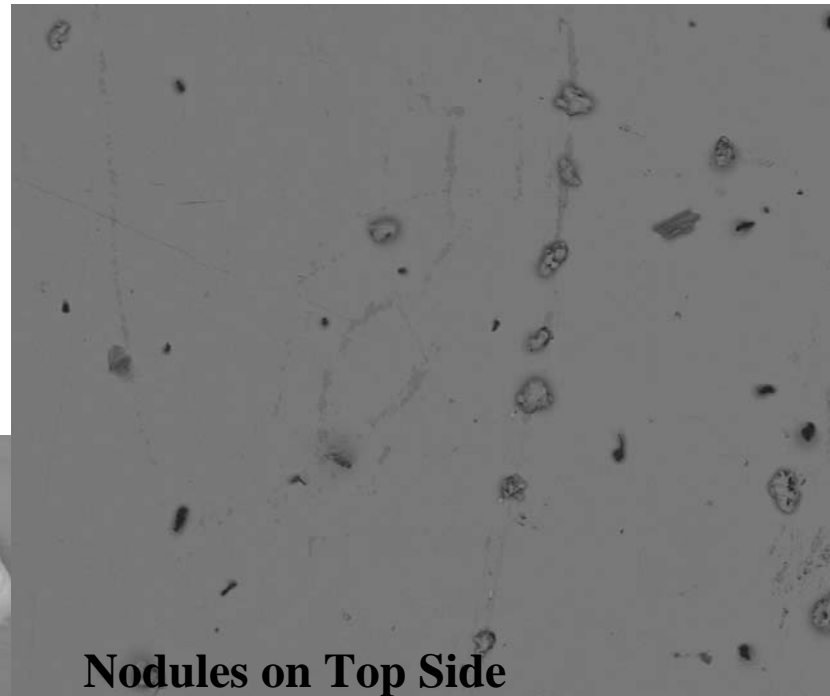
**Nodules on Top Side**

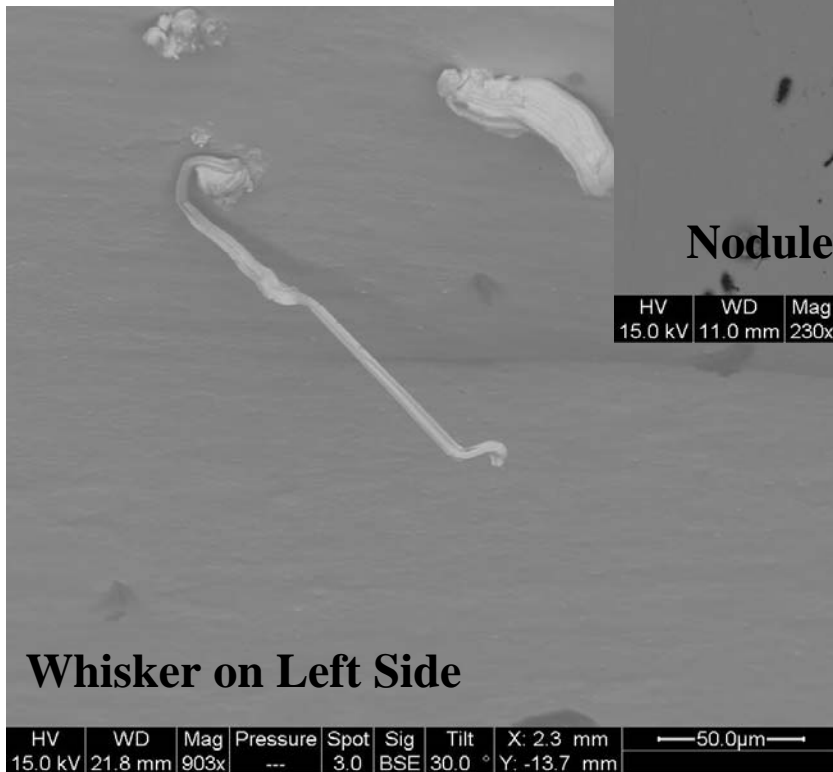
**Whisker on Left Side**

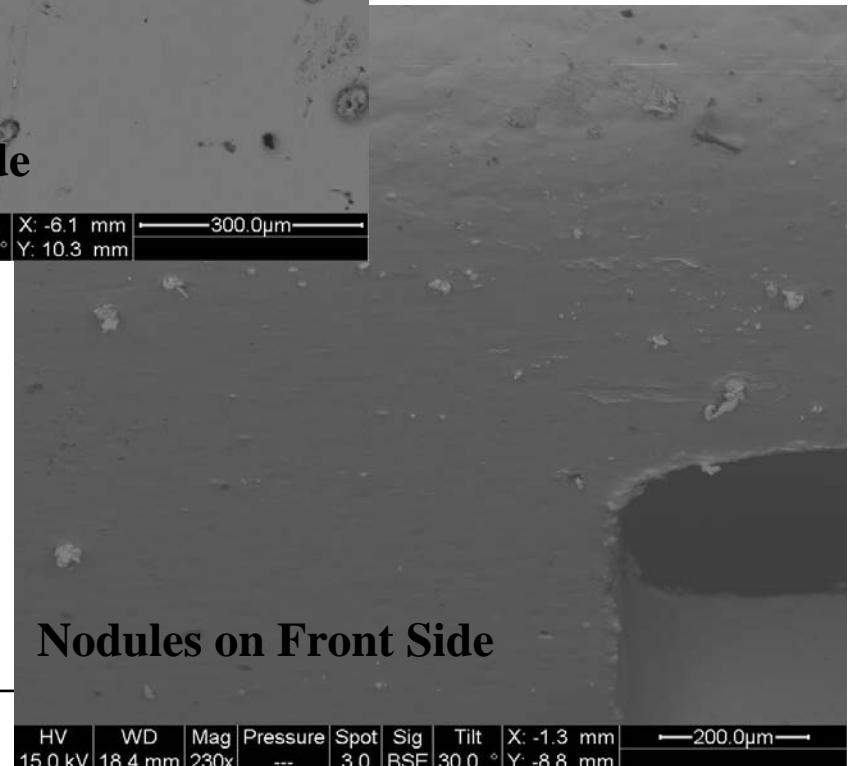
**Nodules on Front Side**

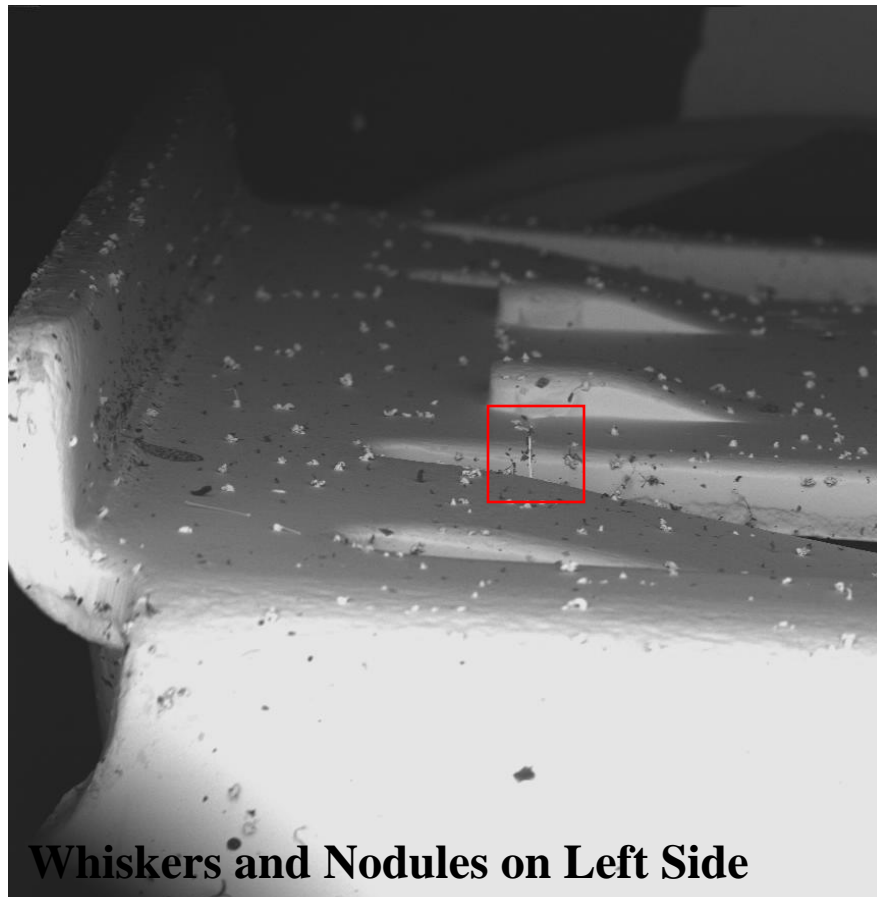
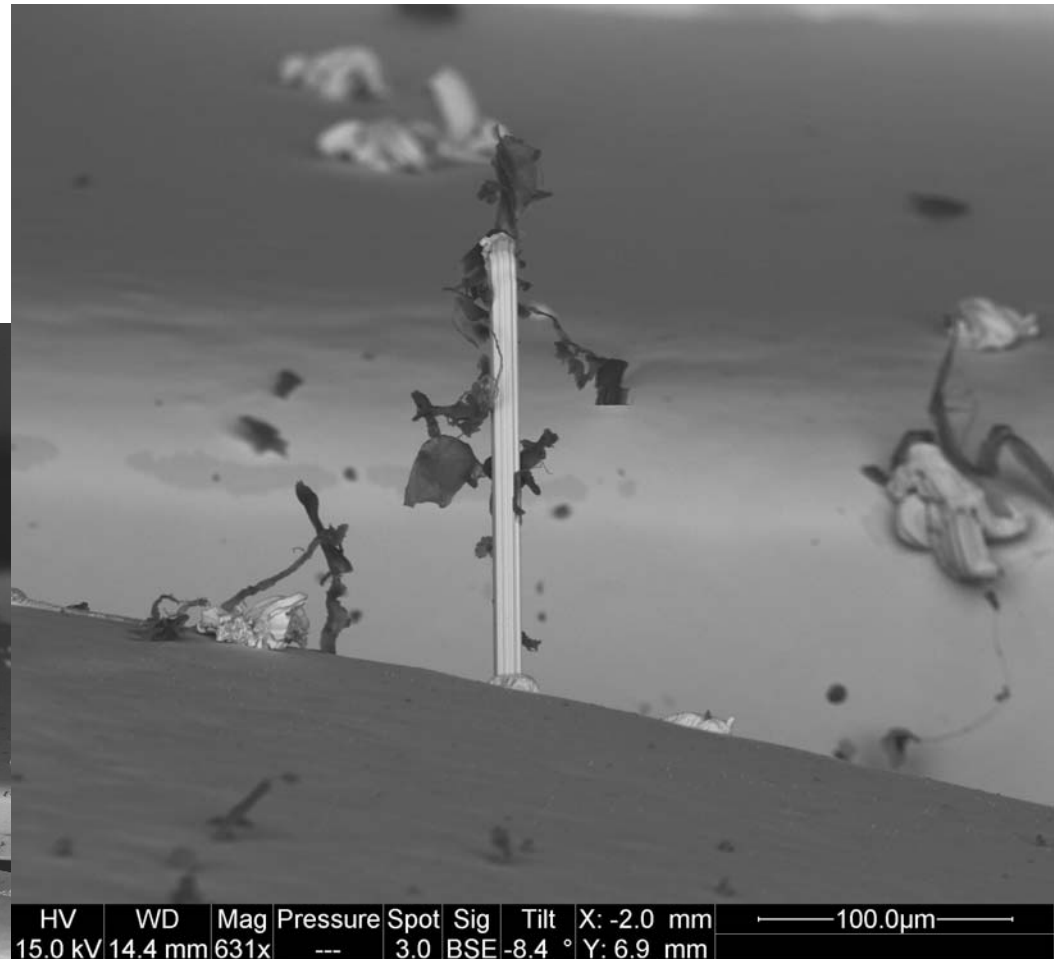
# Board 0335 – USB “A” #2

Whiskers and Nodules on Left Side

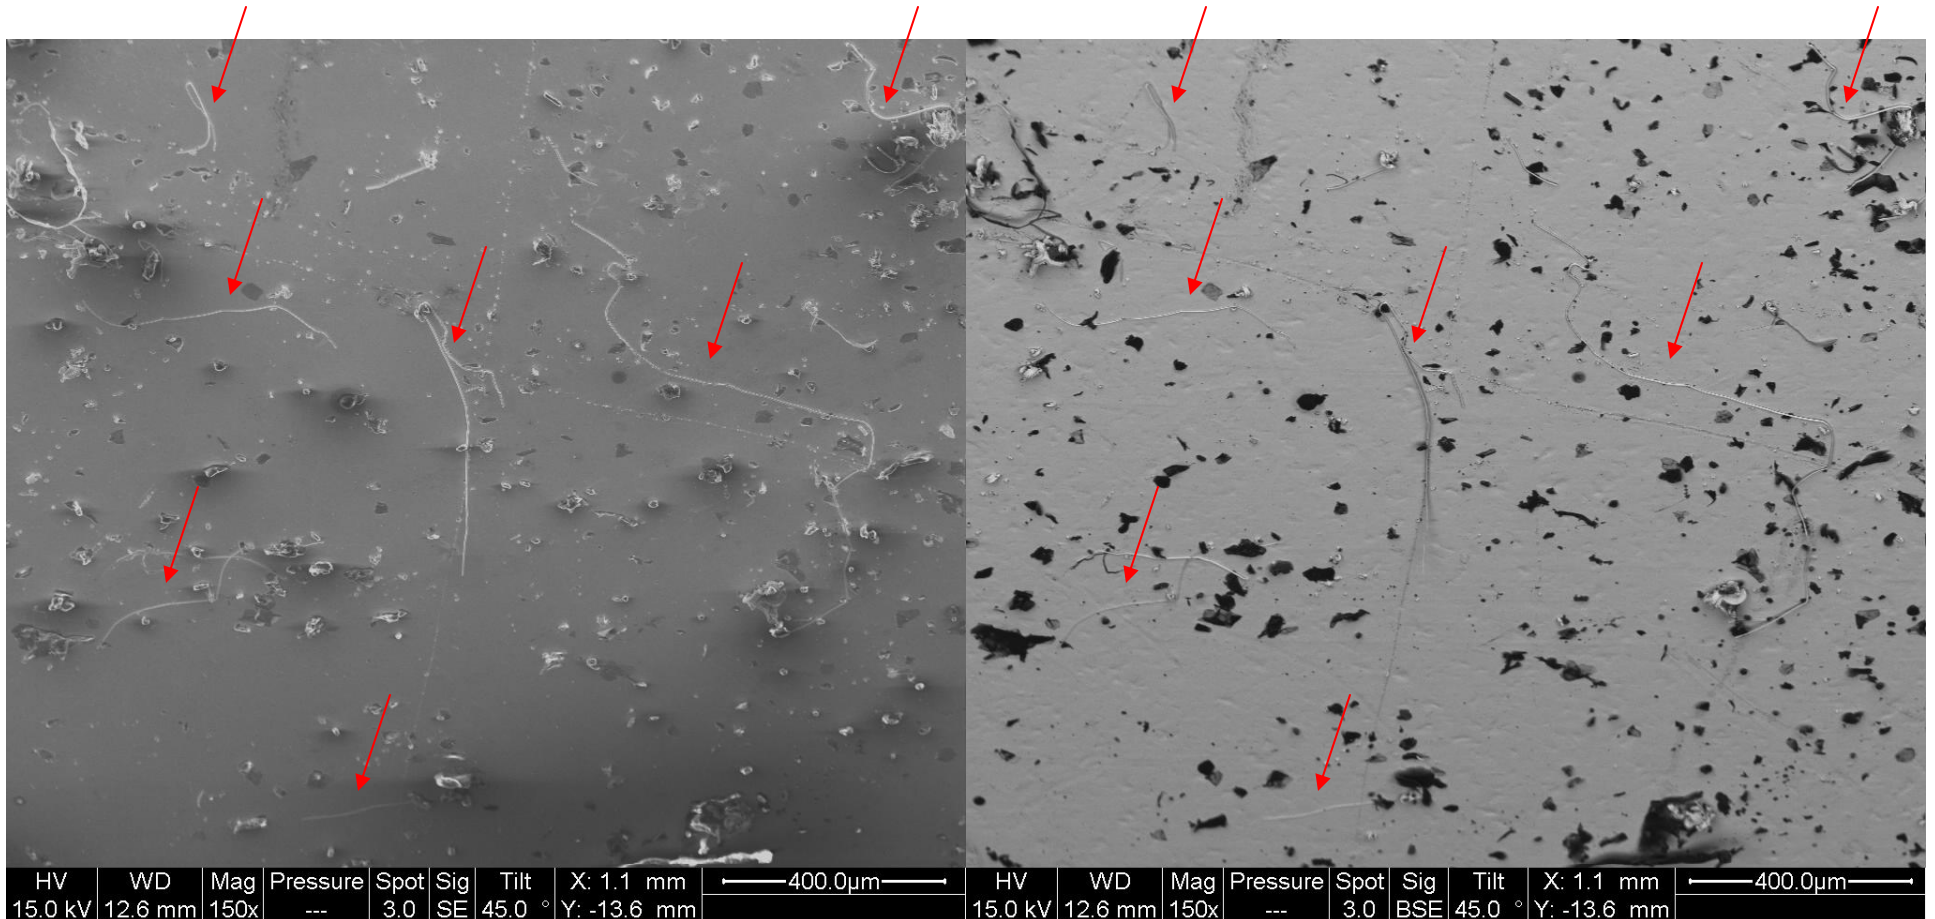
# Board 0337 – USB “B” Back Side

- Lots of debris, and a variety of long broken and bent whiskers
