# Whiskers on Monitor PCBs

September 5, 2008

Two (2) failed monitors were physically examined to assess potential failures. Long metal whiskers ( $> 900$  microns) were observed on USB housings. Failure of monitors not directly linked to tin whiskers.

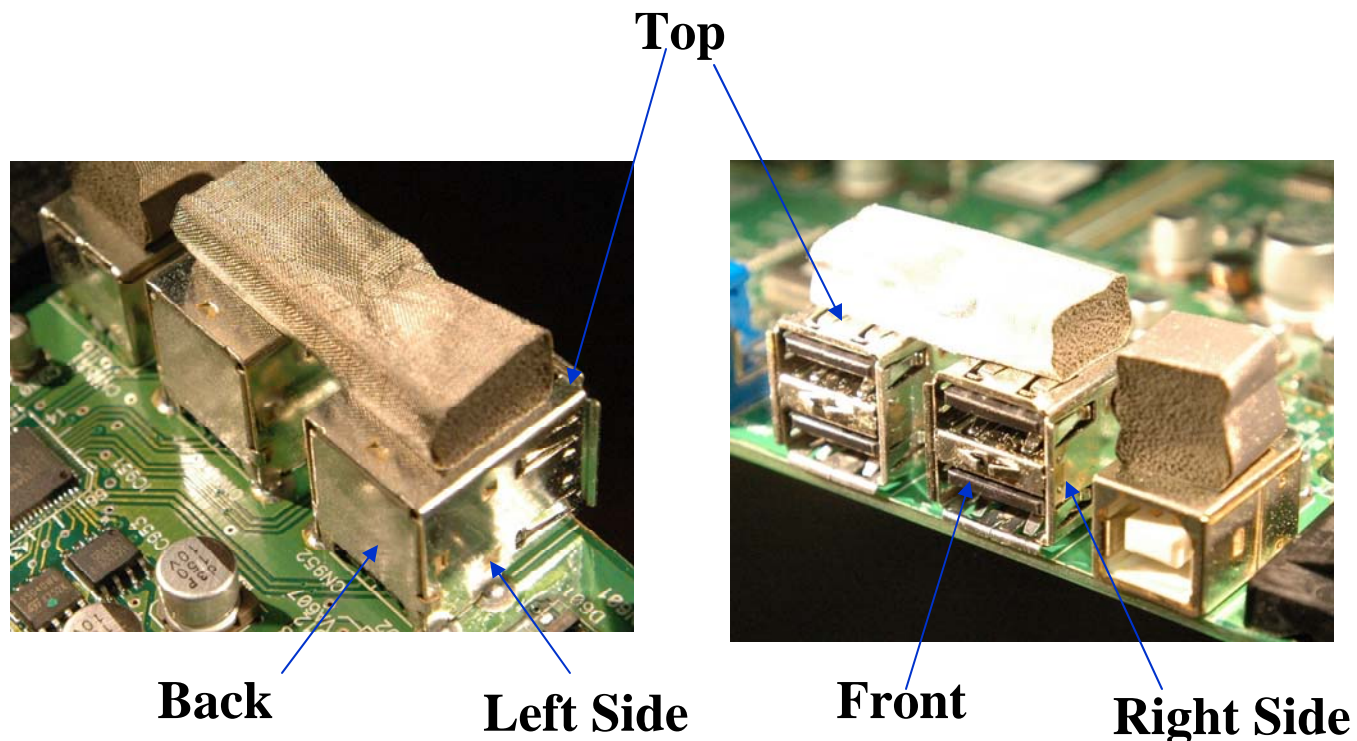
- Upon de-soldering and foam removal, 3 USB connectors observed:
  - USB type “A” from board 0335 (mostly nodulation, some whiskers  $300\mu\text{m}$ )
  - USB type “B” from board 0337 (lots of nodulation, whiskers  $>500\mu\text{m}$ )
- Observations made on top, front, two sides, and back of each connector
