- What are Metal Whiskers (Tin and Zinc)?
- Why are Whiskers a Concern?
- Some Whisker Mitigation Strategies
- Closing Comments

Metal Whisker Discussion

What are Tin (and Zinc) Whiskers?

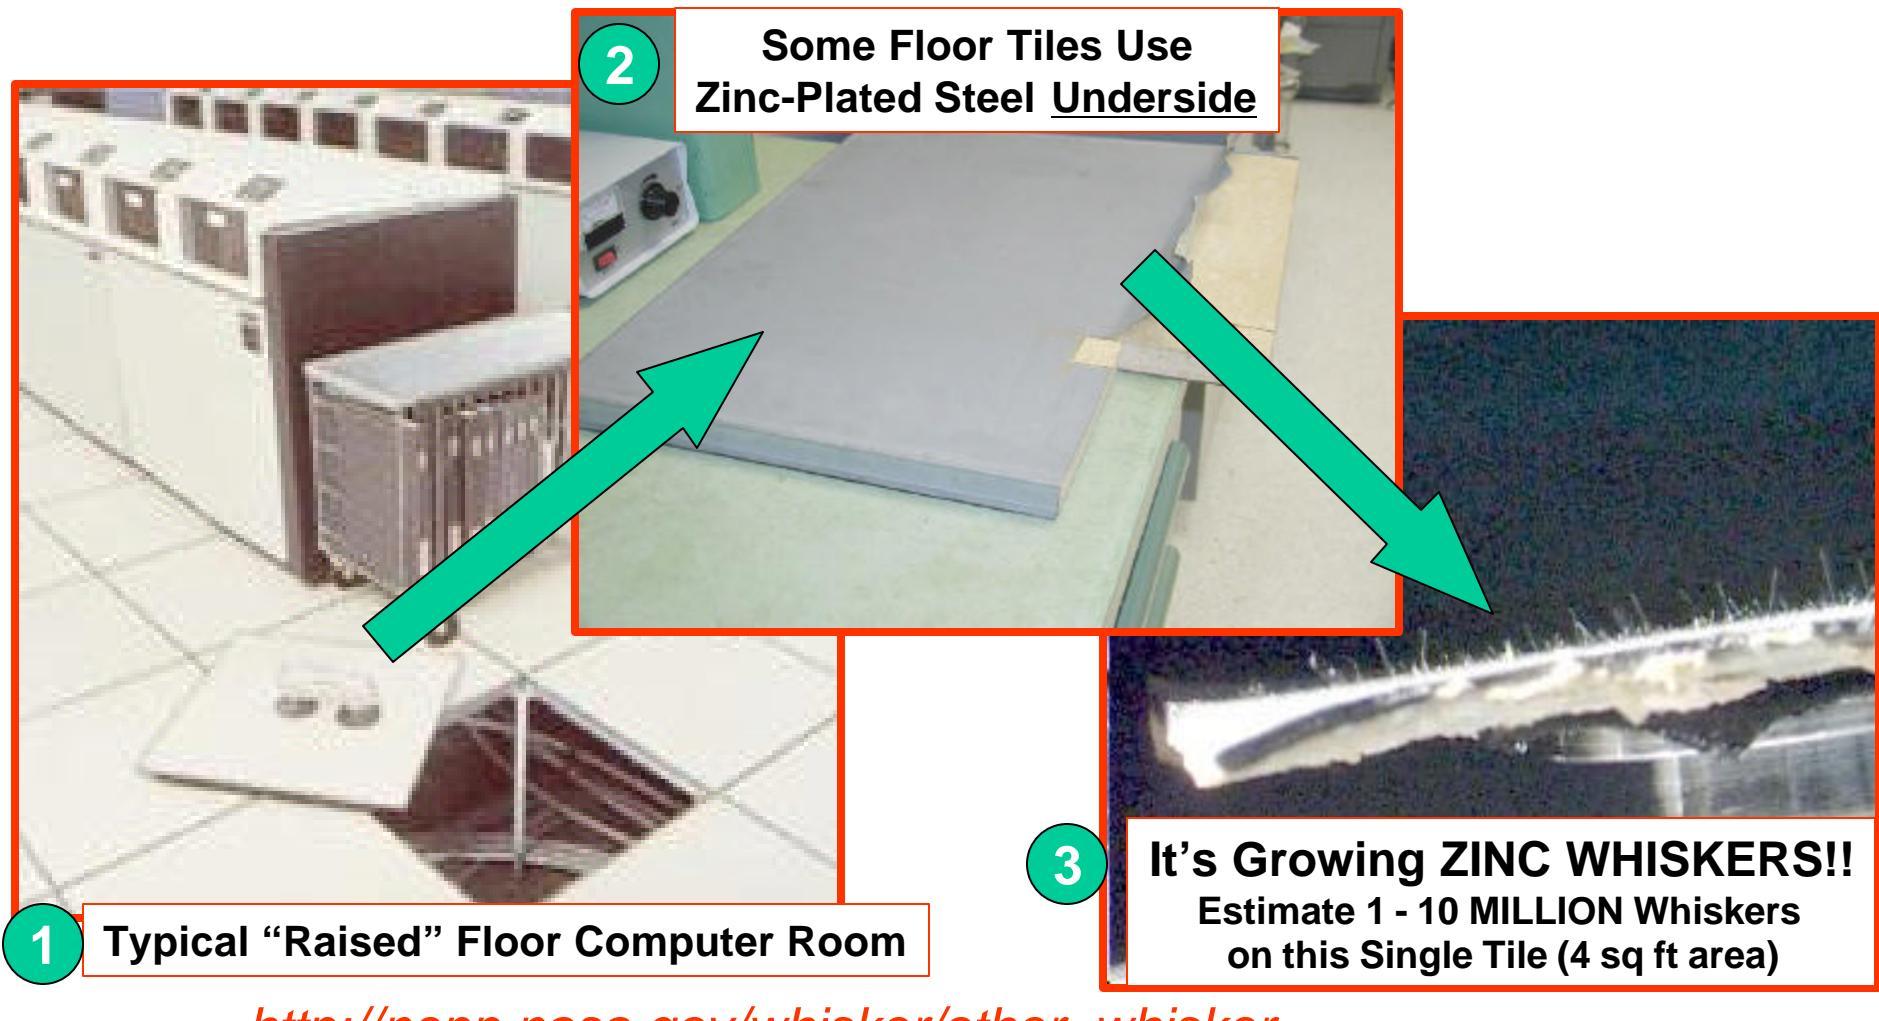
<u>BEWARE! ZINC Whiskers May Be</u> Growing on Your Raised Floor Structures

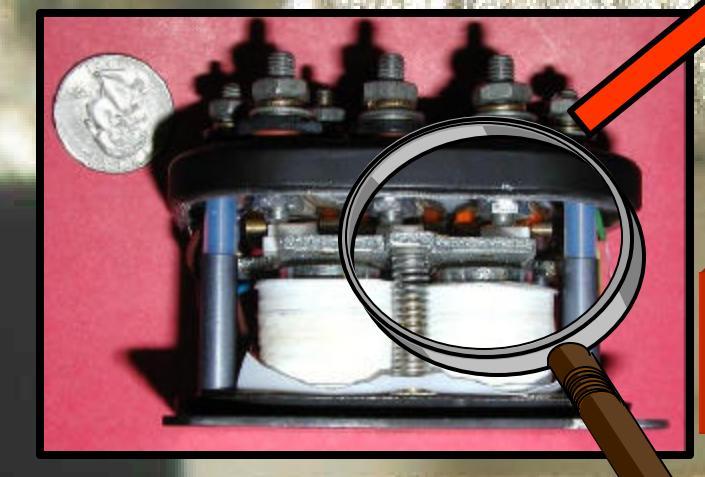
<u>INTERIOR</u> Surfaces of <u>Electromagnetic Relays</u> (*Tin-Plated Steel Armature*) ~14 Years Old Observed in 2002

Beware What May be <u>INSIDE</u> your Devices (Up to 3 mm Long Found in This Part)

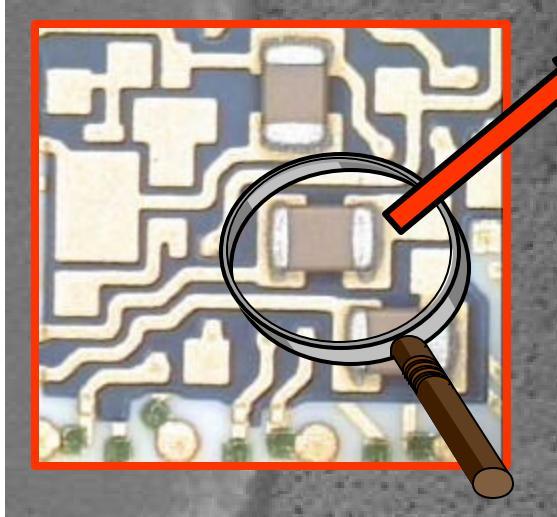
Ceramic Chip Capacitor (Pure Tin-Plate Over Nickel Terminations) Observed in 2001

> <u>Conductive Epoxy Mounted</u> Inside Hermetically Sealed Hybrid

Whiskers appeared AFTER Thermal Cycle -40°C / +90°C (~200 Cycles Shown Here)

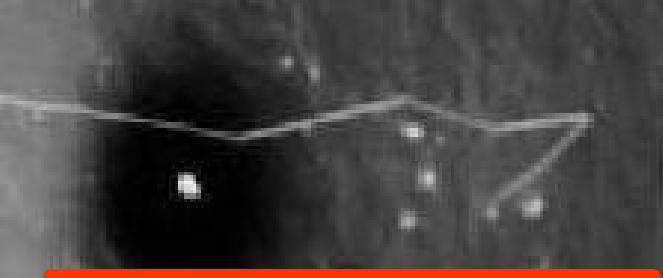
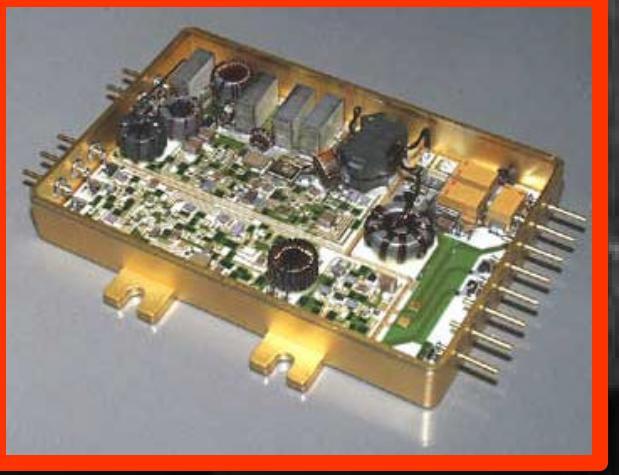
Hybrid Microcircuit Package Lid (Pure Tin-Plated) Observed in 1998

2 mm Long Whiskers Found Growing Toward INSIDE of Package

Whiskers Like these Reportedly Have Broken Loose Inside Hybrids Creating Intermittent Shorts/Field Failures

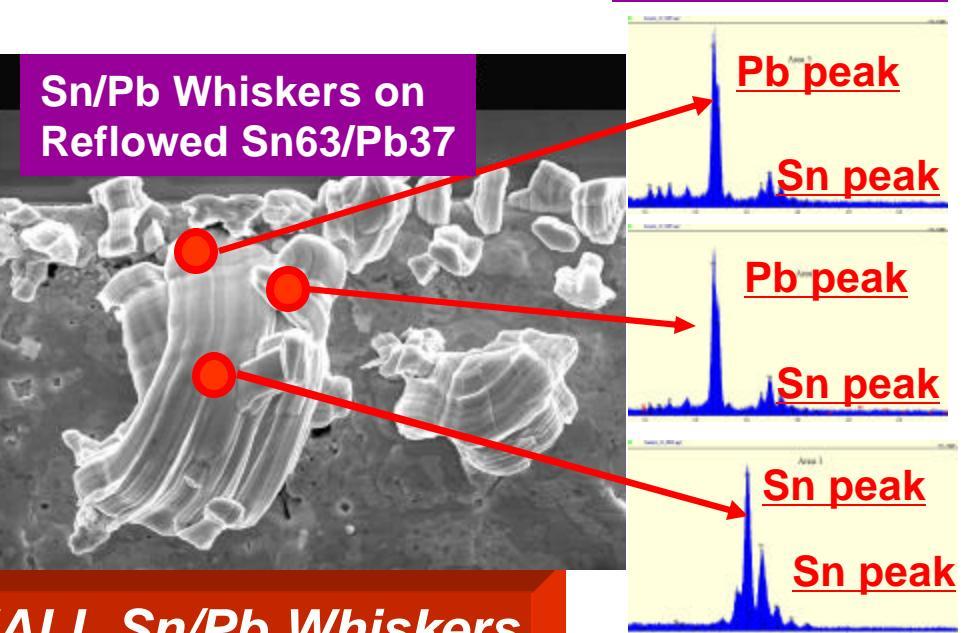
A Bonafide <u>Sn-Pb</u> Whisker Induced Short

Whiskers from <u>REFLOWED Sn-Pb Eutectic Solder</u> (Sn63Pb37) Min. Shorting Distance = <u>3 microns Heat Sink to Semiconductor</u>

Is THIS the Melted Tip of what was once a Longer Sn-Pb Whisker?

"Splatter" Remants from a Melted Sn-Pb Whisker?

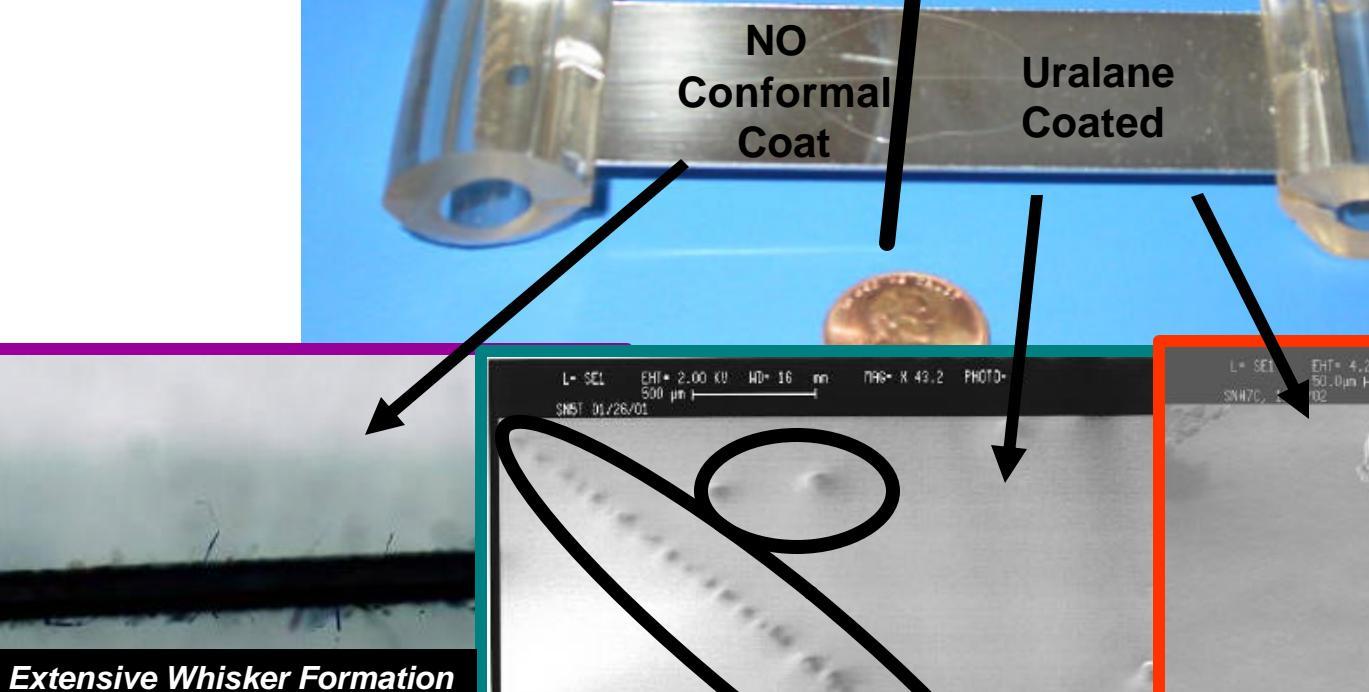
NASA Goddard Whisker Mitigation Study Conformal Coat (Uralane 5750 Polyurethane)

Whisker Farm = "Bright" Tin-Plated Brass Coupon ¹/₂ Without Uralane Coating, ¹/₂ With Uralane Coating

HOWEVER, Whisker Escapes thru <u>THIN</u> (~2 to 6 **m**m thick) Conformal Coat In ~ 1 Year

Extensive Whisker Formation (~2mm) on NON-Coated Side

2 mils of Uralane Keeping Whiskers Beneath Coating For 4+ Years (Ongoing)

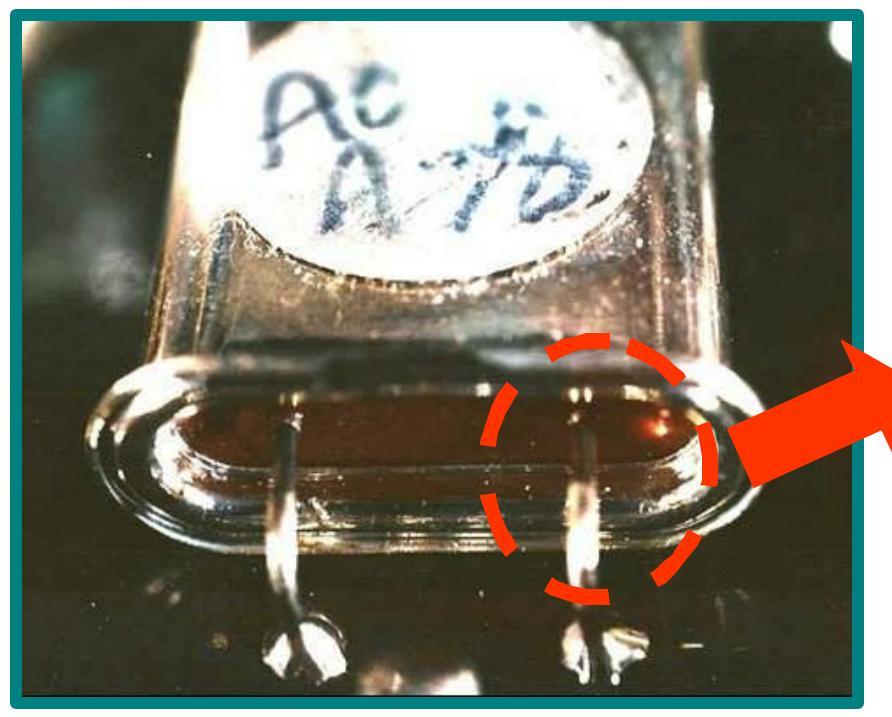
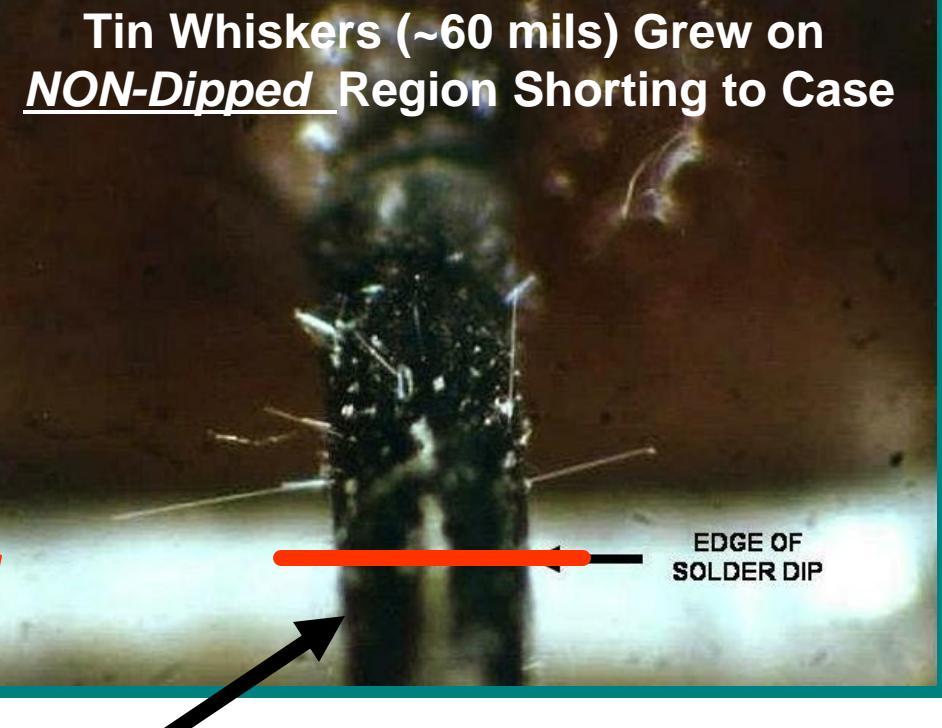
Bright Tin-Plated Kovar Leads (WITH Nickel Underplate)

ONE Year After Assembly

Leads were <u>Hot Solder Dipped</u> (Sn63Pb37) <u>within 50 mils</u> of Glass Seal BEFORE Mounting

<u>NO Whiskers</u> on Hot Solder Dip Region
